Multi-Municipal Wind Turbine Working Group

REPORT ON ONTARIO WIND TURBINE FAILURES

Wind Turbine Failures

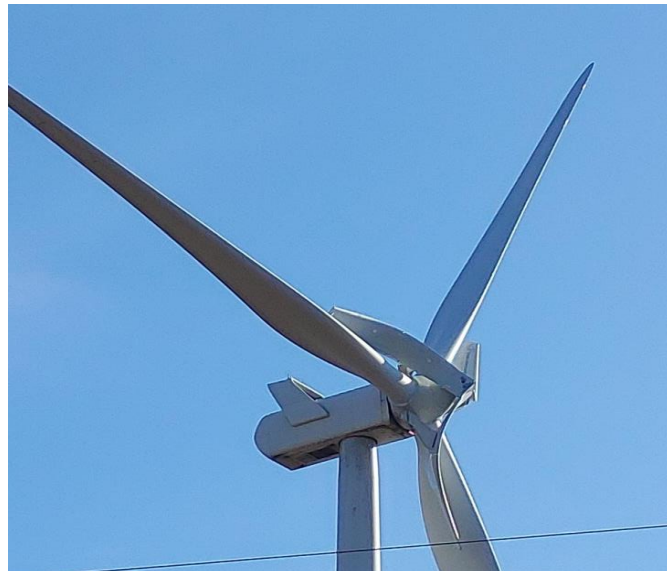
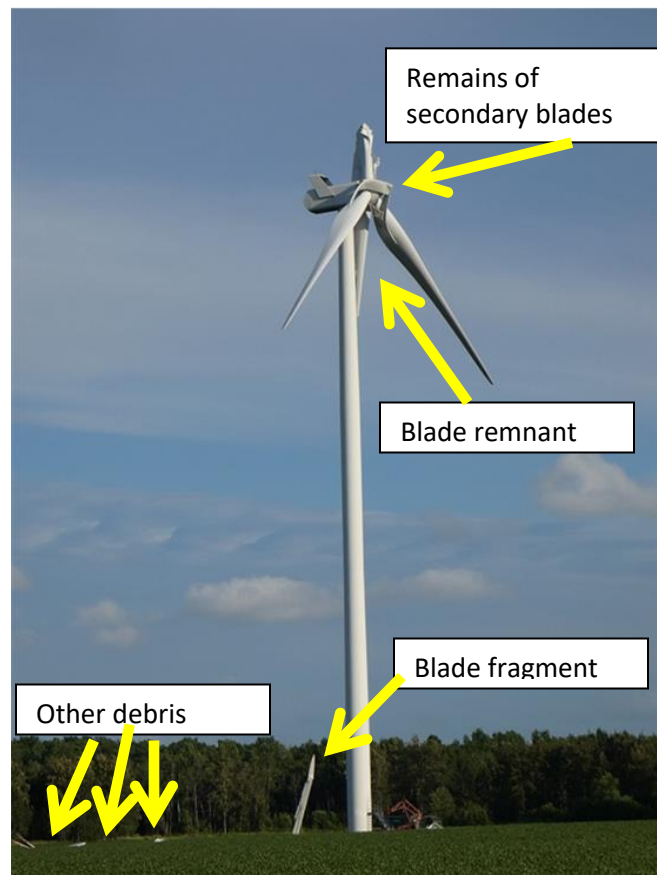
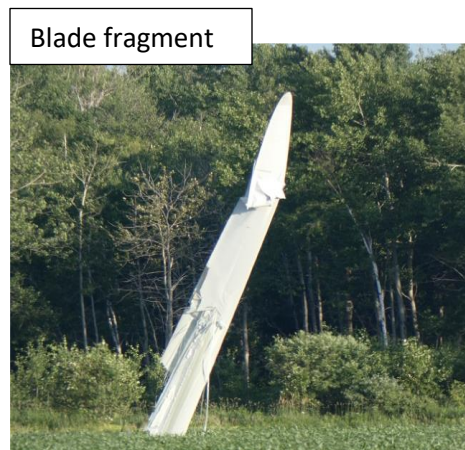
Attachment 2: Skyway 8, Grey County, Ontario

This turbine was retrofitted approximately 3 months prior to the failure with a secondary rotor of three curved blades that fastened to the hub between the existing blades. This experimental device was not part of the original design and was added to increase power output. The failure resulted in the separation of one of the secondary blades and one of the existing blades. Although the exact sequence of the failure is not known, the most likely scenario is that the experimental blade partly separated, impacting the main blade which then failed.

MECP approved the change but there is no public information confirming that the turbine could handle the additional static and dynamic loads imposed by the secondary rotor.

This turbine was located only 195m from the road, Grey Rd. 8. The road closure that was immediately put in place for public safety confirms that existing setback requirements are insufficient. The failure raises many questions concerning how this project was executed and the engineering safety margins for the original wind turbine design.

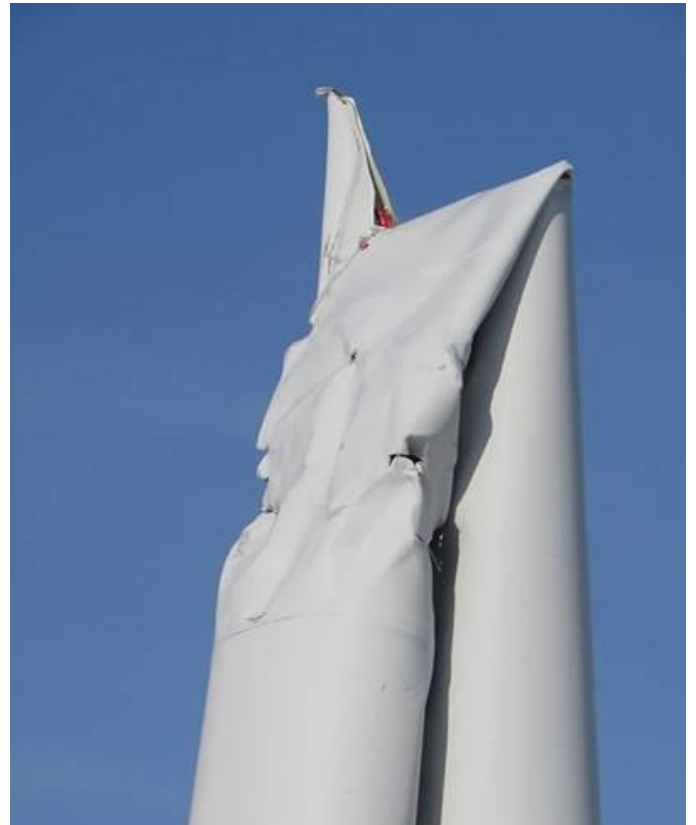
Attachment 3: Raleigh Wind, Chatham-Kent

The company reported that their investigations indicated that the failure was caused by a single faulty blade.

This tower at Chatham-Kent buckled at approximately its midpoint and fell toward the wind. It was found with one blade wrapped around the tower base and markings on the tower that were above the fold line.

Based on the evidence of publicly available pictures, it seems that the most likely scenario for this catastrophic failure was that the tower was struck by a blade which weakened it such that it collapsed.

If the failure was indeed caused by a blade strike on the tower, this raises questions as to how this occurred. This suggests that the clearance may not have been adequate for the conditions encountered during operation. Alternately the blade may have started to separate and this caused it to get so close to the tower that it made contact with it. There may be other possibilities and variations as well.

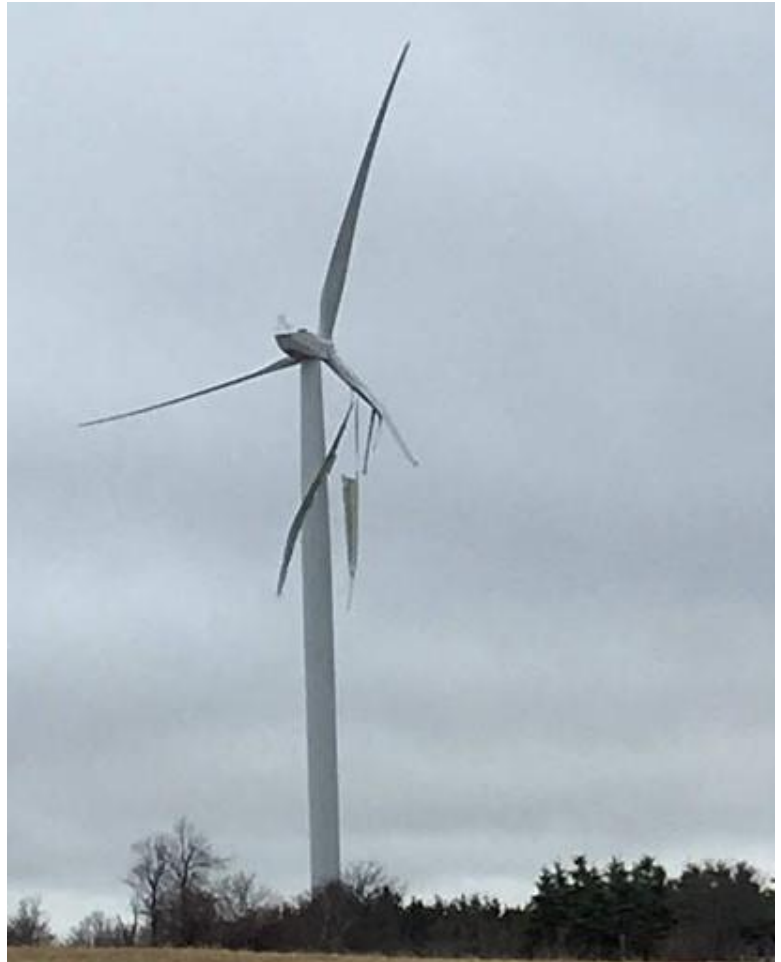
Attachment 4: Sumac Ridge, Kawartha Lakes

Residents reported hearing a grinding sound followed by a loud explosion at 9 a.m. on the morning of the incident.

It was found that one of the blades of the turbine had shattered. Parts of the blade fell to the ground while other pieces were still dangling off of the remaining sections of the blade. The nearby road was closed to ensure public safety.

Initial speculation was that the failure may have been related to the strong winds associated with the storm that moved through the area on the previous weekend.

The blade that failed was relatively new having been in operation for only 1.5 years. This highlights the fact that failures can occur at any time during the life of a wind turbine.

If the failure was related to the strong winds, it raises questions concerning the design safety margins.

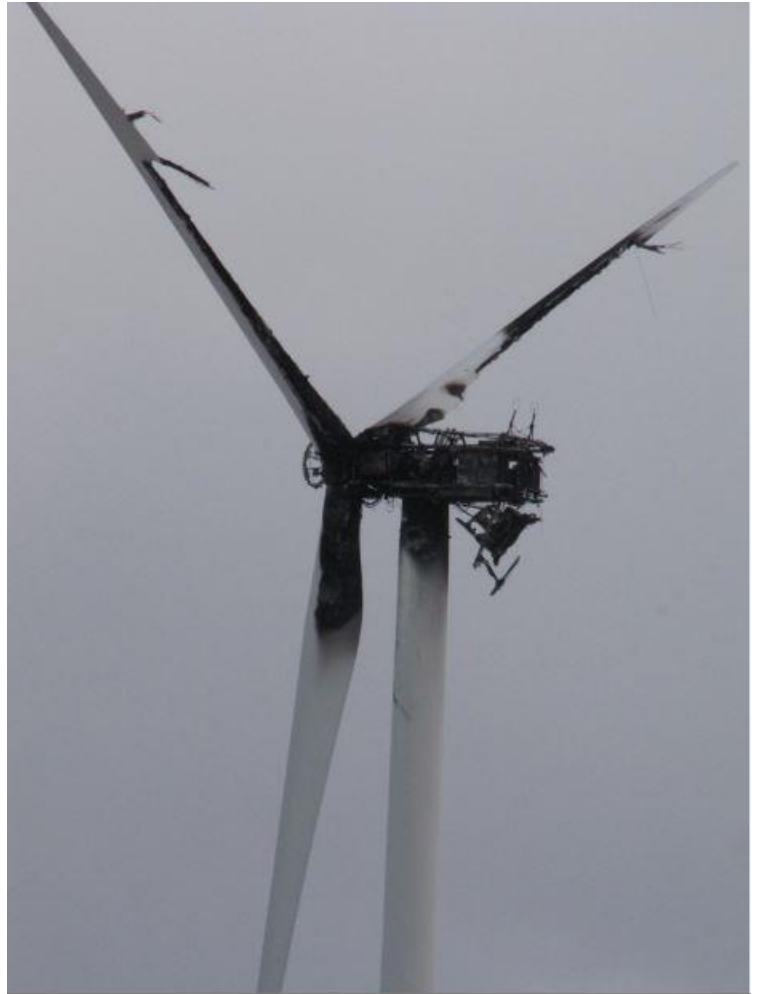
Attachment 5: Kingsbridge 1, Ashfield-Colborne-Wawanosh

The fire started at about 1 am and burned for about two hours. Most of the nacelle was completely destroyed. The intensity of the fire also ignited the blades.

The fire department was called to the site but there was not much that they could do given the elevation of the fire and risks posed by burning pieces of the nacelle and the blades that were falling off of the towers.

Blades continued to rotate and could not be stopped due to the fire in control mechanisms.

A representative of the operator addressed ACW Council the following day and indicated that elements of the turbine were found over 200 metres from the tower.

This failure highlights the need for fire identification and suppression systems to be installed within the nacelles of all wind turbines.

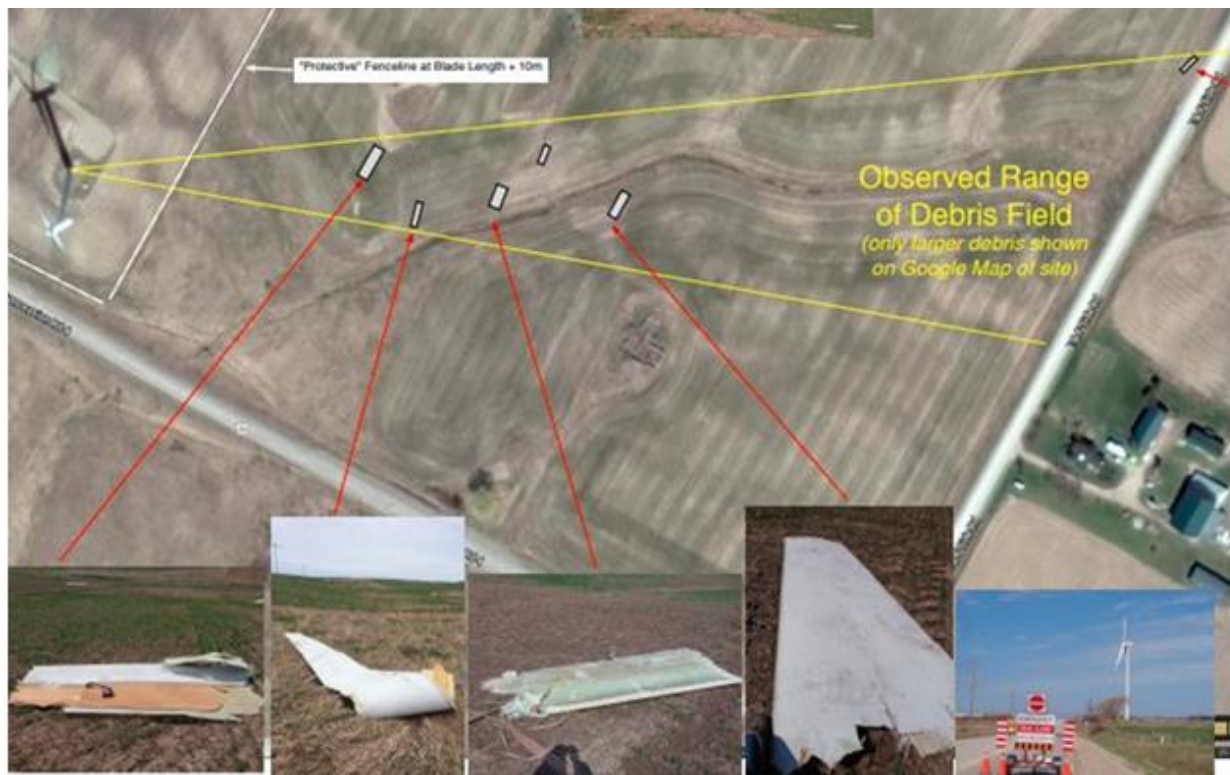
Attachment 6: Huron Wind, Bruce County

The map below compares the limit of the protected area of 50 m with the actual locations of debris from the blade failure. Large pieces of debris found 280 m from the tower.

Debris at 150m from tower - 1.3m X 3.6m

Debris at 170m from tower

Debris at 210 m from tower 1.2m X 3.0m

Debris at 280m from tower 1.2m X 3.0m

Concession 4 closed to danger

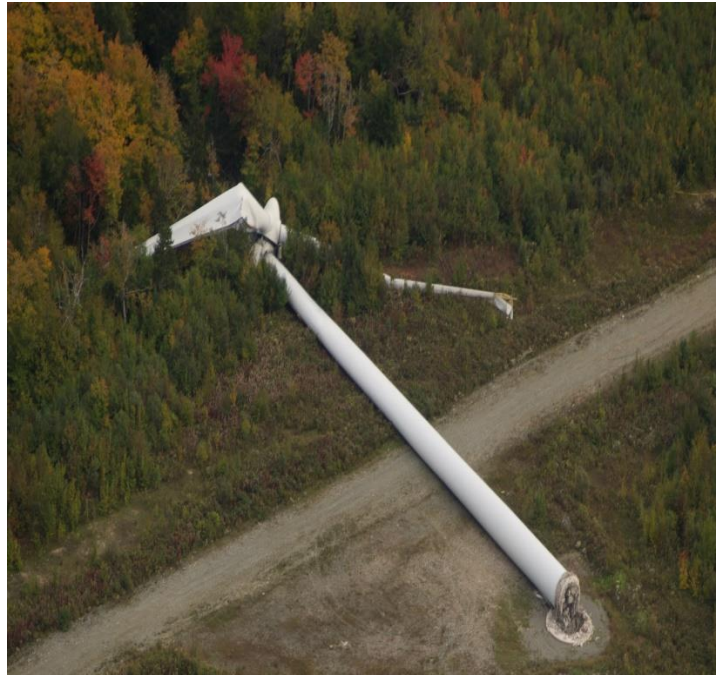
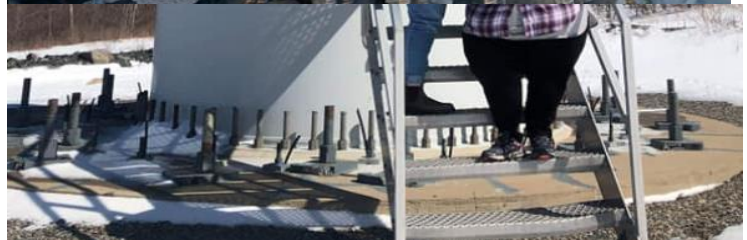
Attachment 7: Kent Hills, New Brunswick

As confirmed by the operator, this tower collapse was linked to a foundation failure (sub-surface crack propagation). The tower itself seems to have all the sections intact and bolted together. Basically, the pictures indicate that the top part of the foundation directly below the tower base was no longer adequately supporting the tower.

A close-up picture of the foundation shows the failed surfaces consists of concrete rubble and rebar. There does not seem to be evidence of the long primary anchor bolts that should fasten to the flange at the base of the tower and then be embedded deep into the concrete foundation.

Earlier pictures taken of wind turbines in this project indicate that numerous anchor bolts had been installed in the concrete bases. This is highly unusual and suggests that they were added when problems with the foundations became evident.

The foundation problem(s) that caused the failure are very likely not an isolated case. Foundation failures can result from many factors i.e., faulty design, quality control, construction techniques, procedures etc.
