Mechanical failure behind crash of Ontario wind turbine experiment

A device developed as part of a \$4.9-million experiment to improve wind turbine efficiency and reduce noise failed — but questions remain unanswered.

October 2024

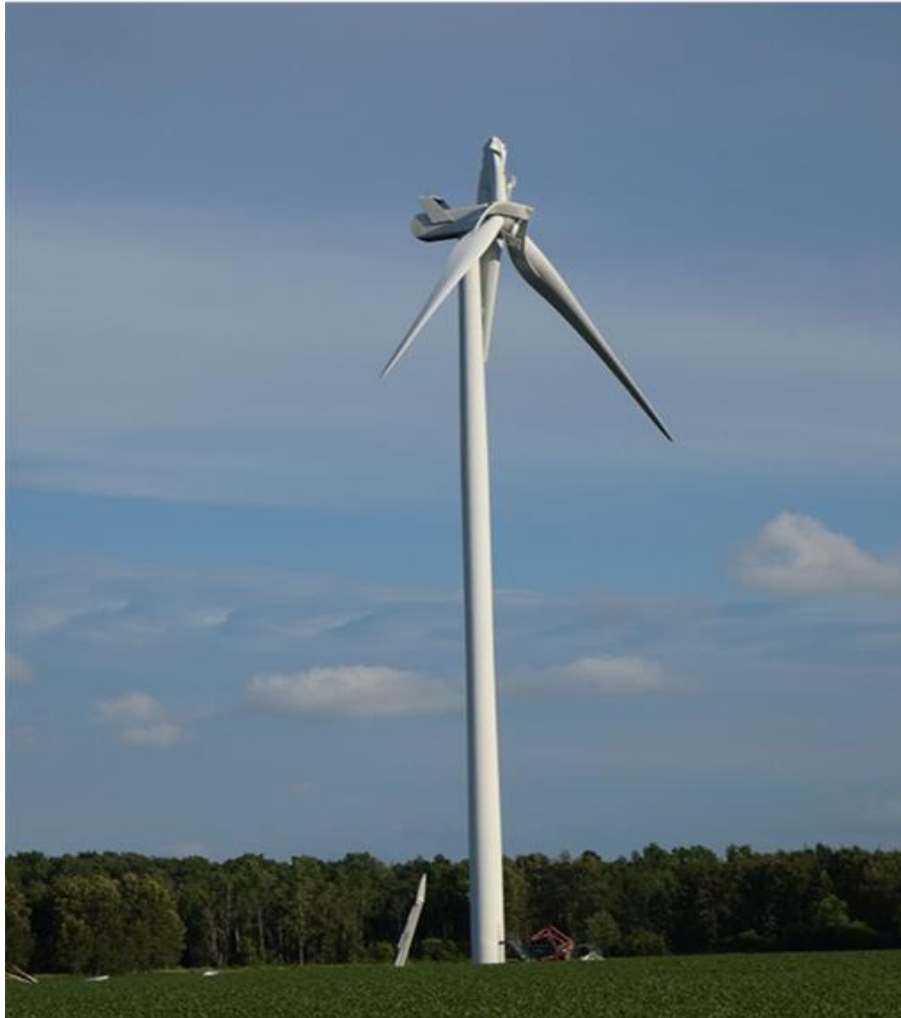
Skyway 8 wind turbine showing blade remnants, partial PowerCone device, and debris. [Photo: M.L. Morfitt]

Capstone then goes on to report to the MECP that the Root Cause Analysis revealed that **“hardware used to secure the PowerCone® to the hub of the turbine failed in operation due to fatigue loads** and as a result the PowerCone® became loose. Once a number of bolts failed under fatigue loads, there was insufficient carrying capacity in the remaining bolts.” [Emphasis ours]

Once that happened, Capstone said, the blades and brackets for the device being tested struck one of the turbine blades, which led to imbalance in operation.

They do not describe the extent of the failure which was that a large portion of turbine blade was thrown to the ground and lodged in the earth, resembling a huge sword. (See photo.)

The actual report prepared by Complete Wind was not provided in response to the FOI request but an Executive Summary was provided, in the tranche of documents.⁶ The Summary offers a little more detail, describing the event as bolts failing “in an instantaneous manner...and while failing it impacted initially with the LE [leading edge] of the rotor blade, resulting in catastrophic impact.”⁷
